Spatial and temporal variability in dune field: Pea Island, North Carolina

This coastal observation was prepared using data from the NCDOT NC 12 Coastal Monitoring Program, and illustrates the spatial and temporal variability in the dune field along Pea Island over the 2014 study year.

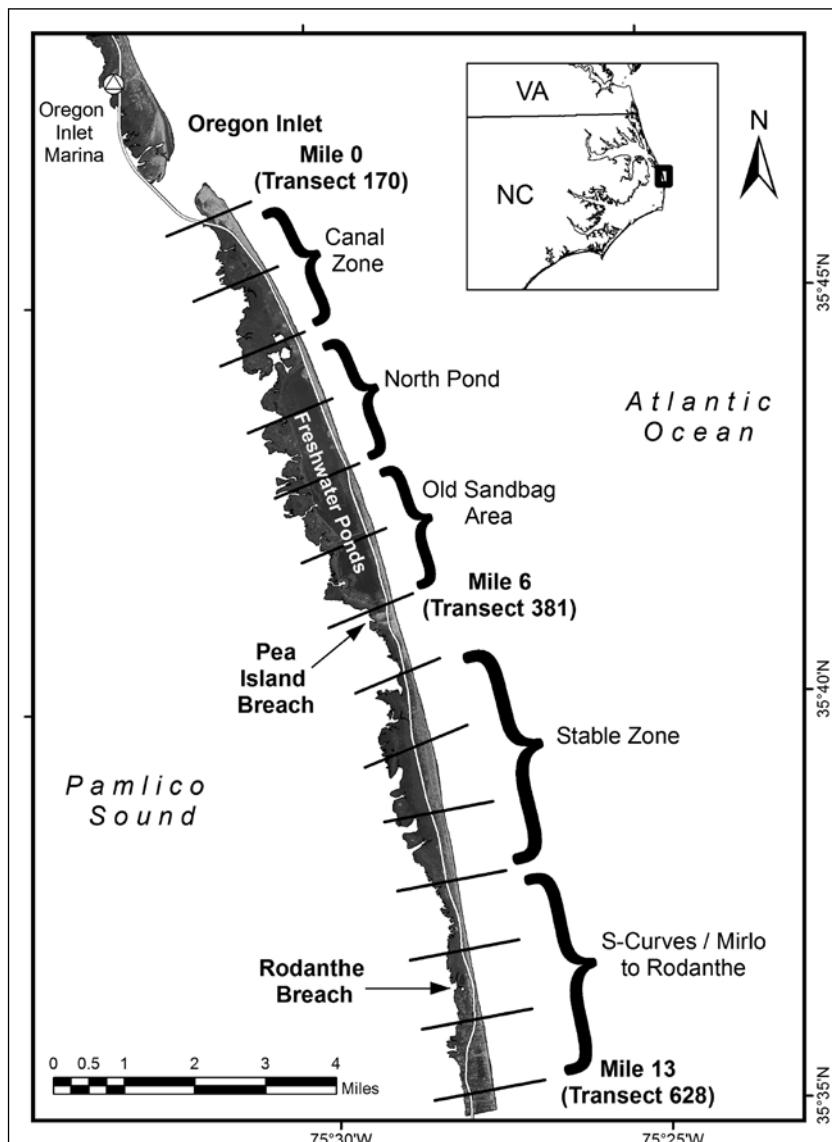
Figure 1. Location map of Pea Island. Reference transects are shown at 1-mile intervals along the coastal monitoring program study area. The location of the NOAA station ORIN7, Oregon Inlet Marina is shown for reference. The Oregon Inlet waverider buoy is located approximately 10 miles offshore east of Mile 1. The white line indicates the NC 12 highway location along Pea Island.

Pea Island is an approximately 13-mile stretch of primarily undeveloped barrier island along the North Carolina Outer Banks, extending from Oregon Inlet south to the town of Rodanthe (Figure 1). While named as an “island,” this region now exists as the northern tip of Hatteras Island, with the shoreline adjacent to the inlet stabilized by a terminal groin built in 1989-1991. It is home to the Pea Island National Wildlife Refuge, established in 1938. The Cape Hatteras National Seashore, established in 1953, is co-located within the refuge boundaries on Pea Island and extends further north and south along the Outer Banks. There is limited infrastructure on Pea Island, consisting of a visitor’s center and other facilities associated with the wildlife refuge, as well as the coastal highway NC 12.

In general, barrier dunes first constructed in the 1930s and sporadically maintained thereafter have been degraded over the intervening years by storms and long-term erosion. In late August 2011, the island was impacted by Hurricane Irene, and two breaches formed, one just south of Mile 6 and one in northern Rodanthe (approx. Mile 11.5), eliminating the dune field in those locations (Figure 1).

Island shoreline (approximately Miles 10-12 on Figure 1). This project included placement of approximately 1.5 M cy of sand, using material from an offshore borrow site. The northern portion of this project included a constructed dune with elevation +15 ft NAVD 88. It is noted that this project is on a far smaller scale than the original barrier foredune construction, and was designed to provide temporary protection while NCDOT developed alternatives for sustaining the transportation corridor along this highly vulnerable stretch of roadway.

Along the first four miles of the study area, the running average maximum elevations range from approximately 12-20 ft and are highly variable from date to date. From Miles 4 to 6, the maximum elevations are higher, at approximately 18-22 ft. Near Mile 6, at the site of the Pea Island Breach, dunes were completely removed and elevations are on the order of 10 ft. South of the breach the dune crest elevation increases, transitioning to a relatively stable section of Pea Island between Miles 7 and 10; within this stable area, remnants of the original constructed barrier dunes are still in place. From Miles 10 to 12, the road curves close to the active shoreline in several places, with dune crest elevations ranging from approximately 15-20 ft. South of Mile 12 at the town of Rodanthe, dunes are minimal, with maximum elevations on the order of approximately 12 ft. Table 1 summarizes the characteristics of the alongshore regions, which are also labeled in Figure 1.

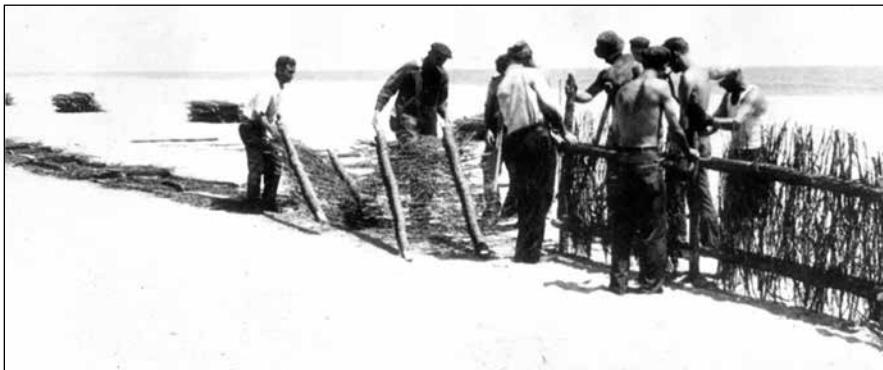
Figure 2. Construction of brush fencing., Photo courtesy National Park Service, Cape Hatteras National Seashore Collection (with permission).

The initial construction was fortified by the National Park Service along the Cape Hatteras National Seashore later in the 1950s using bulldozing, brush sand fencing, and plantings (Birkemeier *et al.*

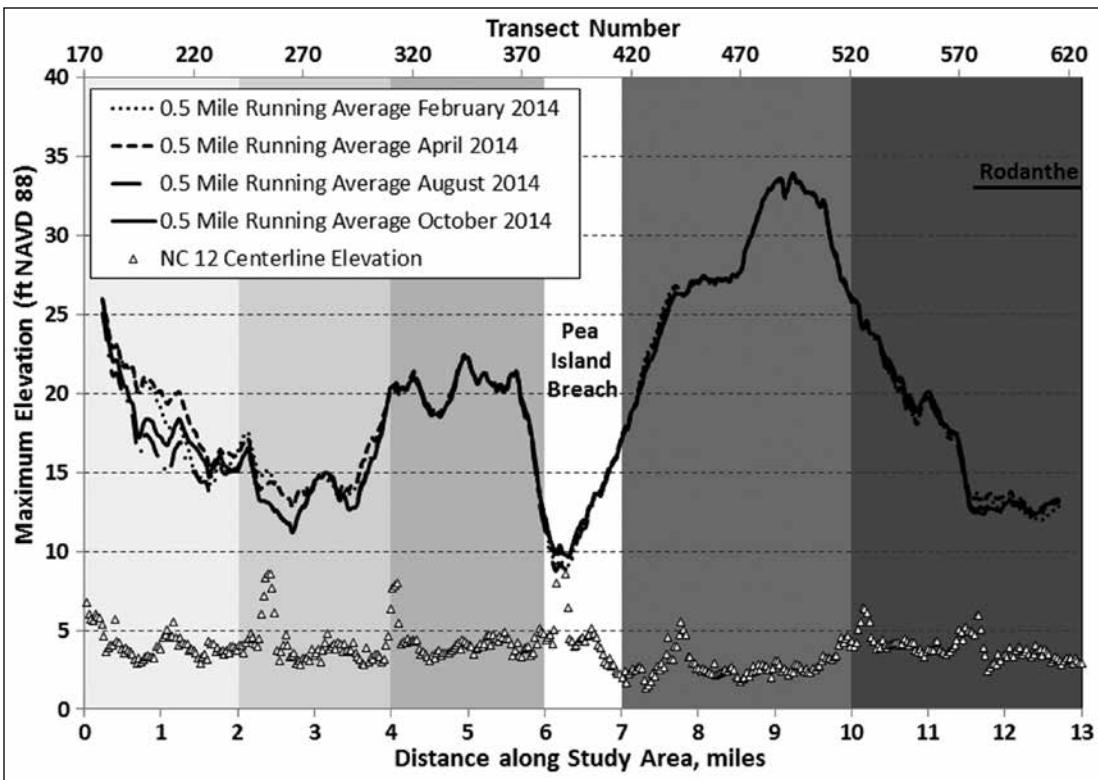
Figure 3. Lines show a 0.5-mile running average of maximum elevation at each transect displayed from north to south along the study area for each topographic data set. Elevations at the centerline of NC 12 are plotted in with hollow triangles for comparison. Background colors correspond to the locations described in Table 1. Modified from Overton (2015).

mately 13 mile study area, substantial spatial variability of the maximum elevation was observed. To visualize alongshore trends, a 0.5-mile running average of the maximum elevation was computed for each of the available dates. Results are shown in Figure 3.

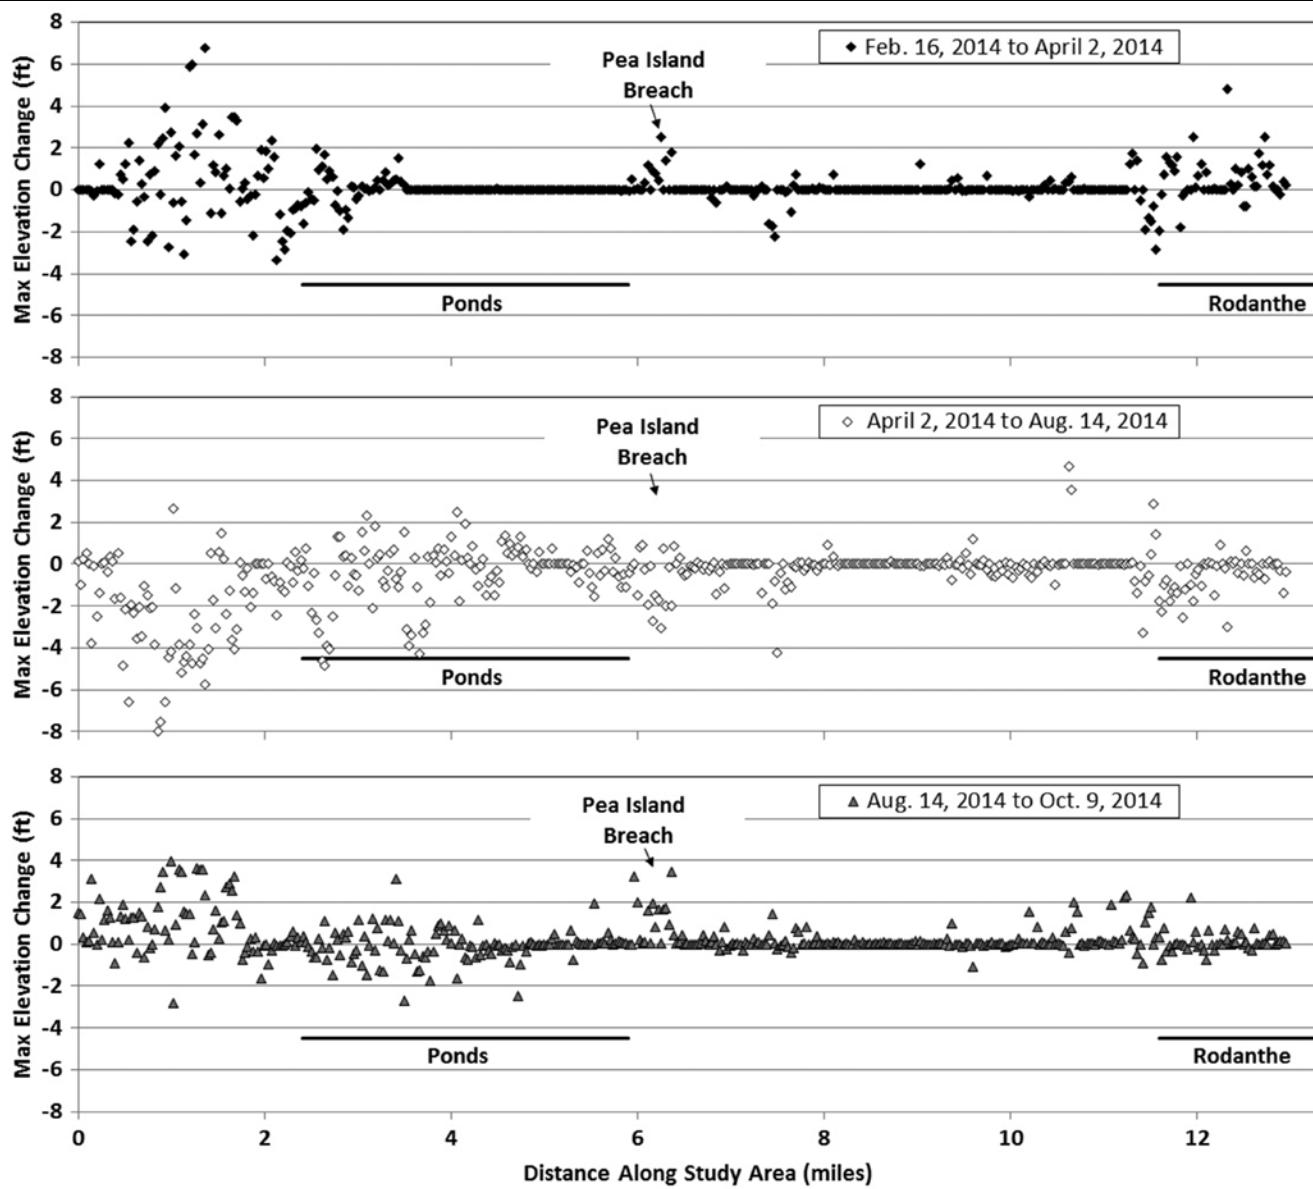
Figure 4. Change in maximum elevation between NC 12 and the shoreline from (A) 16 February 2014 to 2 April 2014, (B) 2 April 2014 to 14 August 2014, and (C) 14 August 2014 to 9 October 2014 at each transect along the study area from north to south. Modified from Overton (2015).

Changes in the maximum elevation in each alongshore region from date to date are shown in this section. Figure 4 shows the changes for all time intervals at each transect across the study area. Negative change means the elevation of the later date was lower than that of the earlier date (decrease in maximum elevation); positive change means that the maximum elevation increased between the two dates. As shown, changes on the order of +/-4 ft occurred frequently throughout the year, especially in the first four miles (Canal Zone and North Pond) and along the southern part of the refuge into Rodanthe (S-Curves/Mirlo Beach). If these changes are examined more closely it becomes clear that anthropogenic influences are responsible for most of the increases in maximum elevation, while decreases can be attributed to wind transport and/or high water levels.

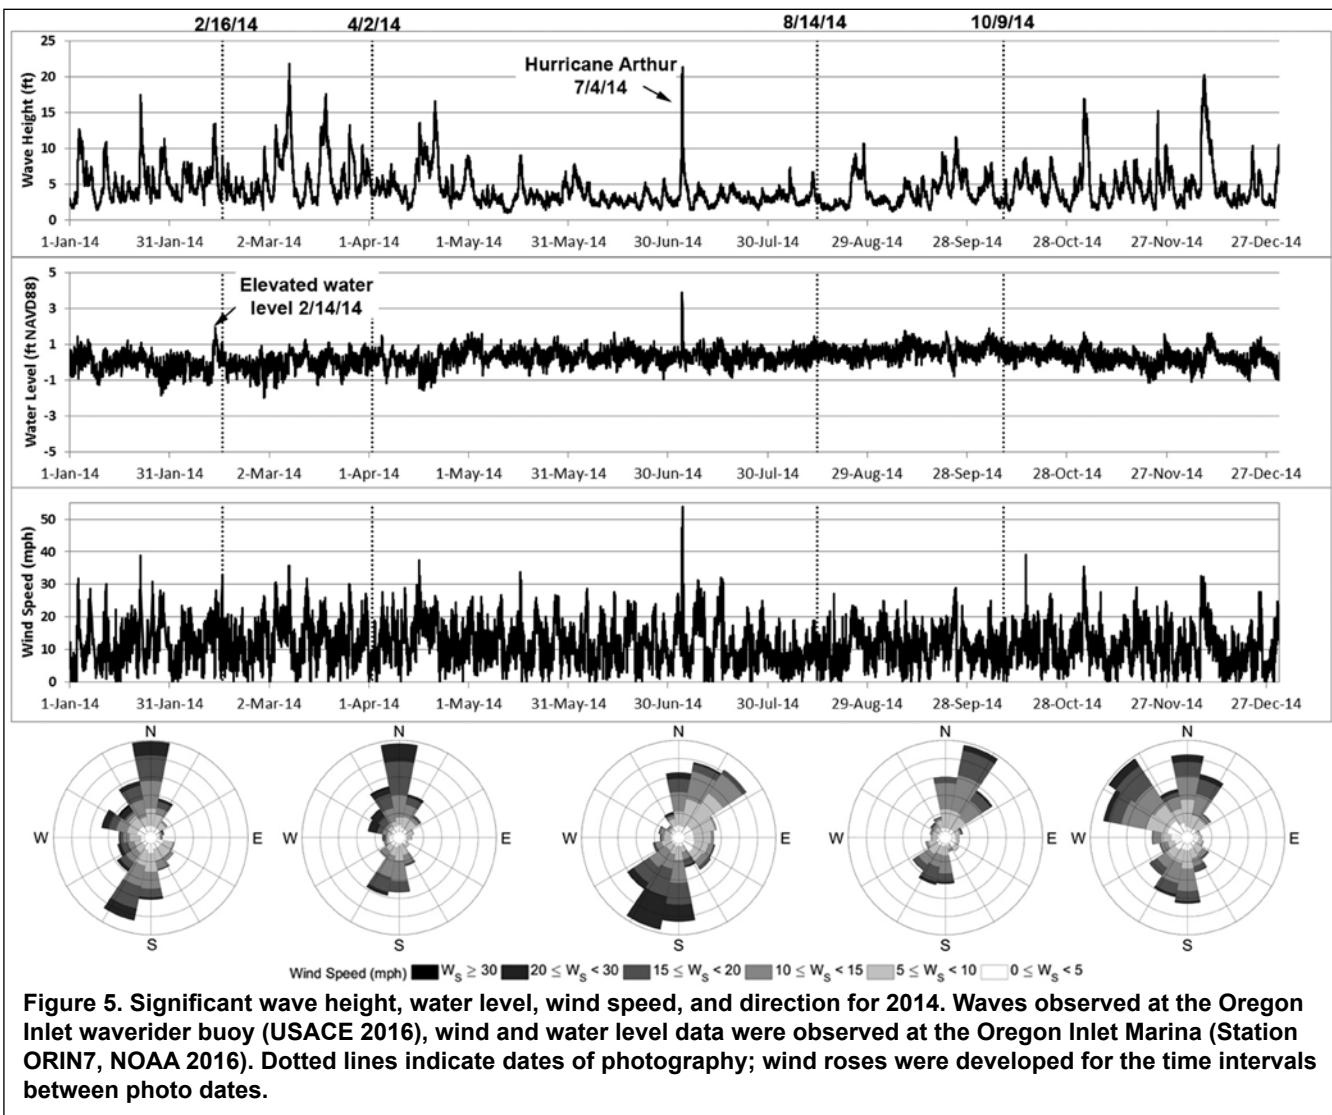
Figure 5. Significant wave height, water level, wind speed, and direction for 2014. Waves observed at the Oregon Inlet waverider buoy (USACE 2016), wind and water level data were observed at the Oregon Inlet Marina (Station ORIN7, NOAA 2016). Dotted lines indicate dates of photography; wind roses were developed for the time intervals between photo dates.

For reference, significant wave heights observed at the 18-m-depth Oregon Inlet waverider buoy (USACE 2016), as well as water level, wind speed, and wind roses developed from data observed at

the Oregon Inlet Marina (NOAA 2016) for the year 2014 are presented in Figure 5. A number of winter storms affected the area during 2014, including elevated water levels in February just before the coastal monitoring program photography was taken on 16 February. In addition, Hurricane Arthur impacted the area on 4 July 2014.

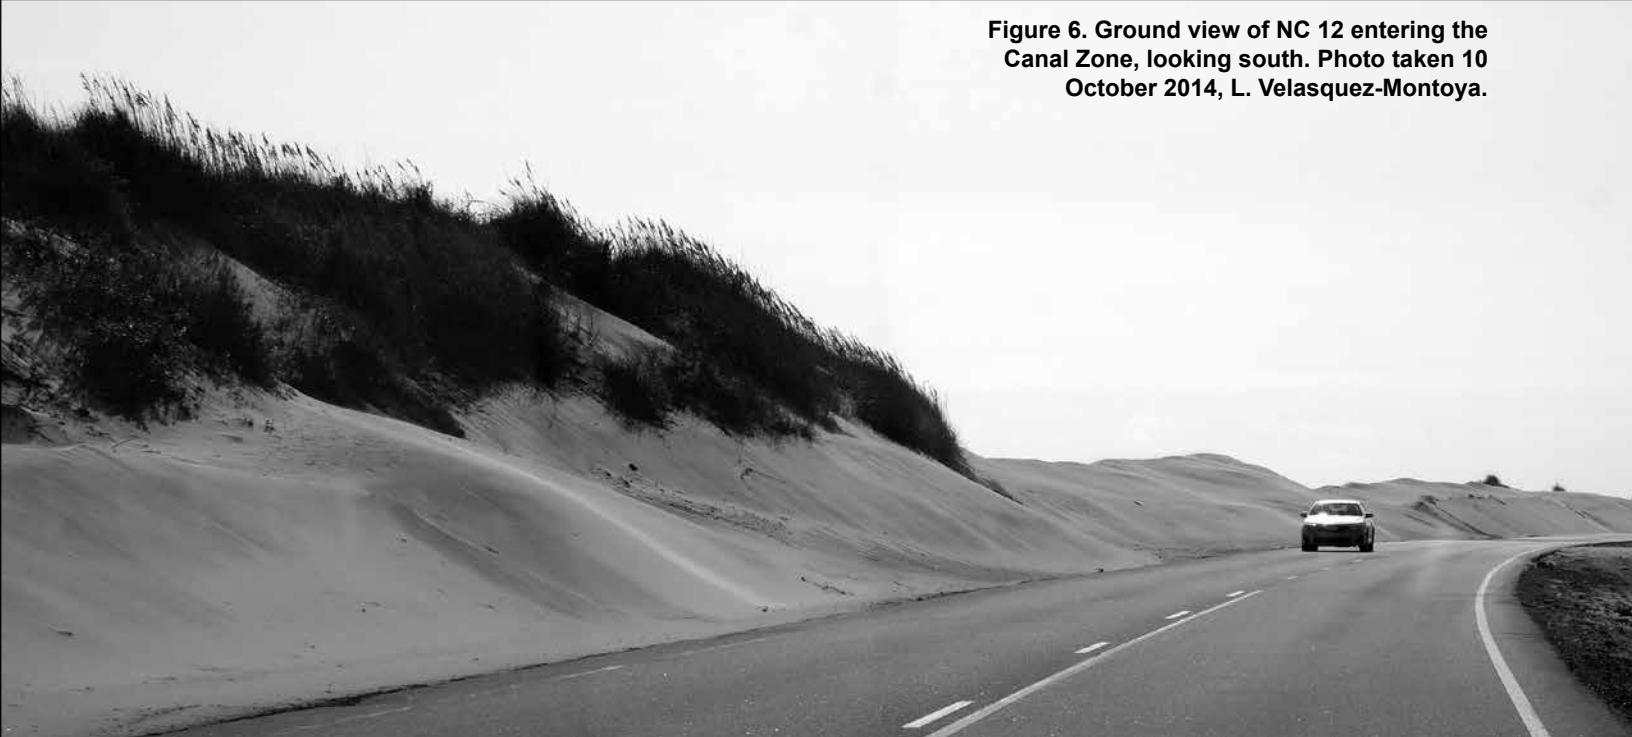
Figure 6. Ground view of NC 12 entering the Canal Zone, looking south. Photo taken 10 October 2014, L. Velasquez-Montoya.

In the Canal Zone region, the dunes are immediately adjacent to the road as shown in Figure 6; sand frequently blows onto NC 12 and during high water levels, tides or surge may pass through breaks in the dunes or overwash low dunes, leading to water on the road. NCDOT regularly conducts earth moving operations along this section of NC 12. Aerial photography taken 16 February 2014 just after a nor'easter storm shows apparent areas of windblown sand and possibly high water being repaired along this region (Figure 7A). To illustrate the variability of the maximum elevations over the study year, the cross-section profile at Mile 1.4 (Transect 219) is shown in Figure 7B. This location showed an increase in maximum elevation from February to April, due to earth-moving operations, with subsequent profile data showing lowering of the crest and widening of the dune profile, likely due to wind-blown sand transport.

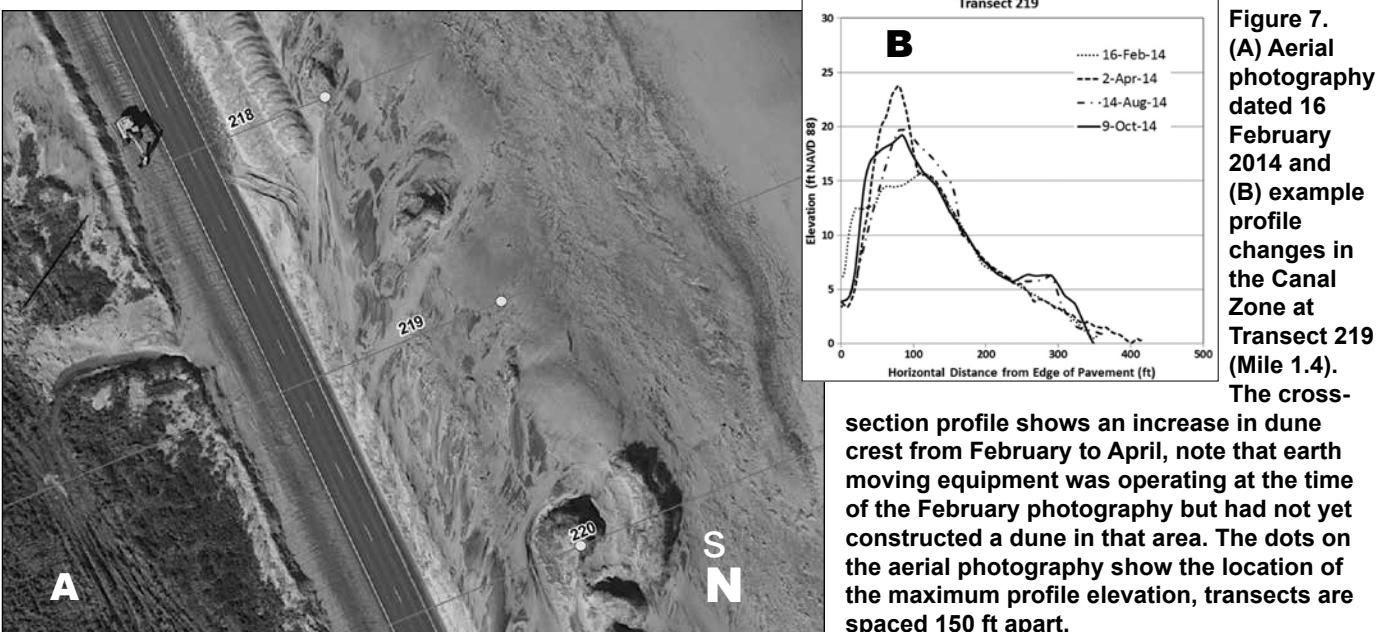
Figure 7.
(A) Aerial photography dated 16 February 2014 and **(B)** example profile changes in the Canal Zone at Transect 219 (Mile 1.4). The cross-section profile shows an increase in dune crest from February to April, note that earth moving equipment was operating at the time of the February photography but had not yet constructed a dune in that area. The dots on the aerial photography show the location of the maximum profile elevation, transects are spaced 150 ft apart.

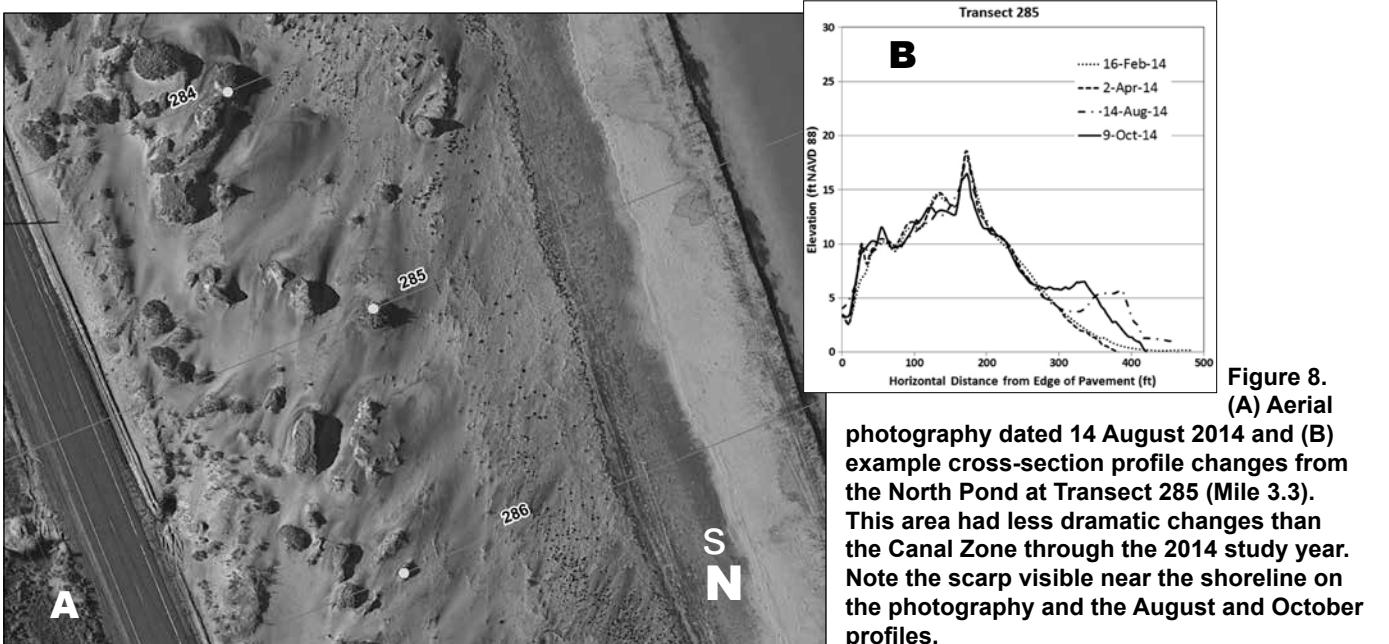
Figure 8.
(A) Aerial photography dated 14 August 2014 and **(B)** example cross-section profile changes from the North Pond at Transect 285 (Mile 3.3). This area had less dramatic changes than the Canal Zone through the 2014 study year. Note the scarp visible near the shoreline on the photography and the August and October profiles.

Figure 8 shows an aerial photo of Transect 285 (Mile 3.3) as well as the cross-sectional profile changes over the 2014 study year. Changes at this profile were less dramatic than the changes shown in Figure 7; variability in the maximum elevation was on the order of 2 ft over the 2014 study year. The most significant changes along this transect oc-

curred in the lower portion of the profile, where a landward-migrating berm scarp developed during the summer.

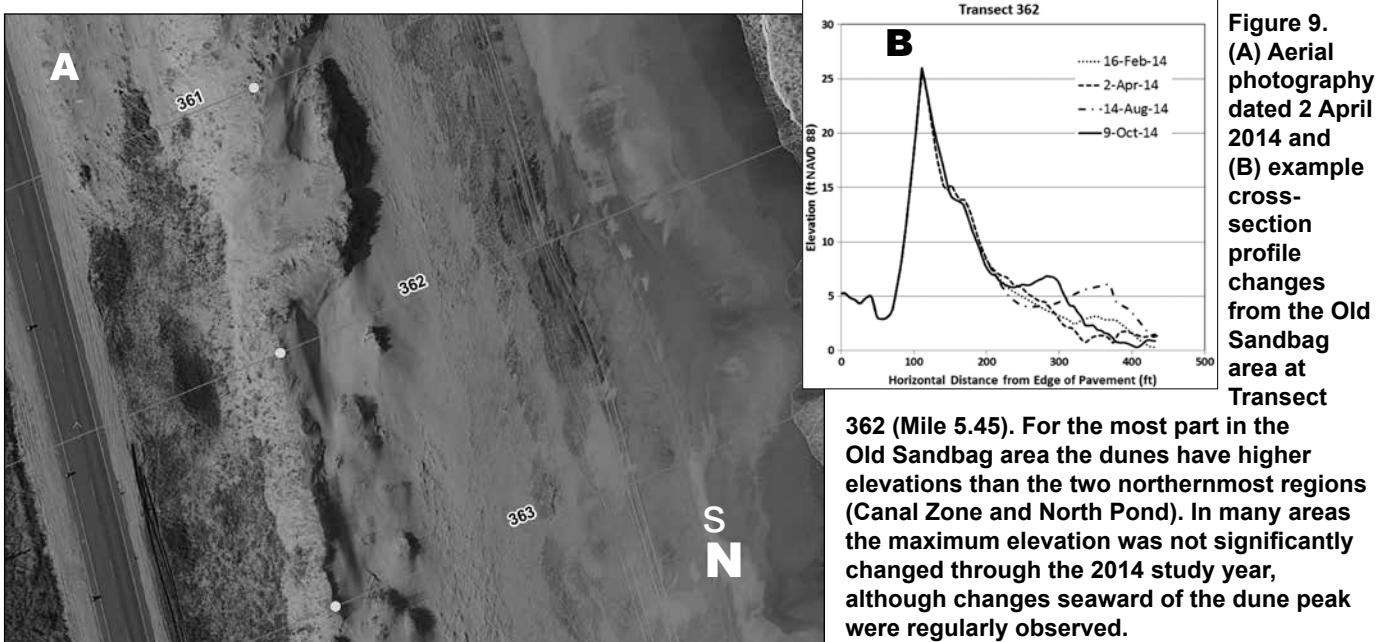
Figure 9.
(A) Aerial photography dated 2 April 2014 and **(B)** example cross-section profile changes from the Old Sandbag area at Transect 362 (Mile 5.45). For the most part in the Old Sandbag area the dunes have higher elevations than the two northernmost regions (Canal Zone and North Pond). In many areas the maximum elevation was not significantly changed through the 2014 study year, although changes seaward of the dune peak were regularly observed.

NC 12 in the Old Sandbag Area was relocated landward in 1996, with dunes rebuilt and vegetation planted in the former location of the road. Because of that effort there is more distance from the edge of pavement to the shoreline and dunes with greater maximum elevation and more vegetation than those further north. In general these dunes are more stable, although there are discontinuities (breaks in the dune line) in a number of places. There were fewer changes in the maximum elevation along this section, than the two northernmost stretches. An example of a dune that did not have changes in the maximum elevation is presented in Figure 9 (Transect 362, Mile 5.45).

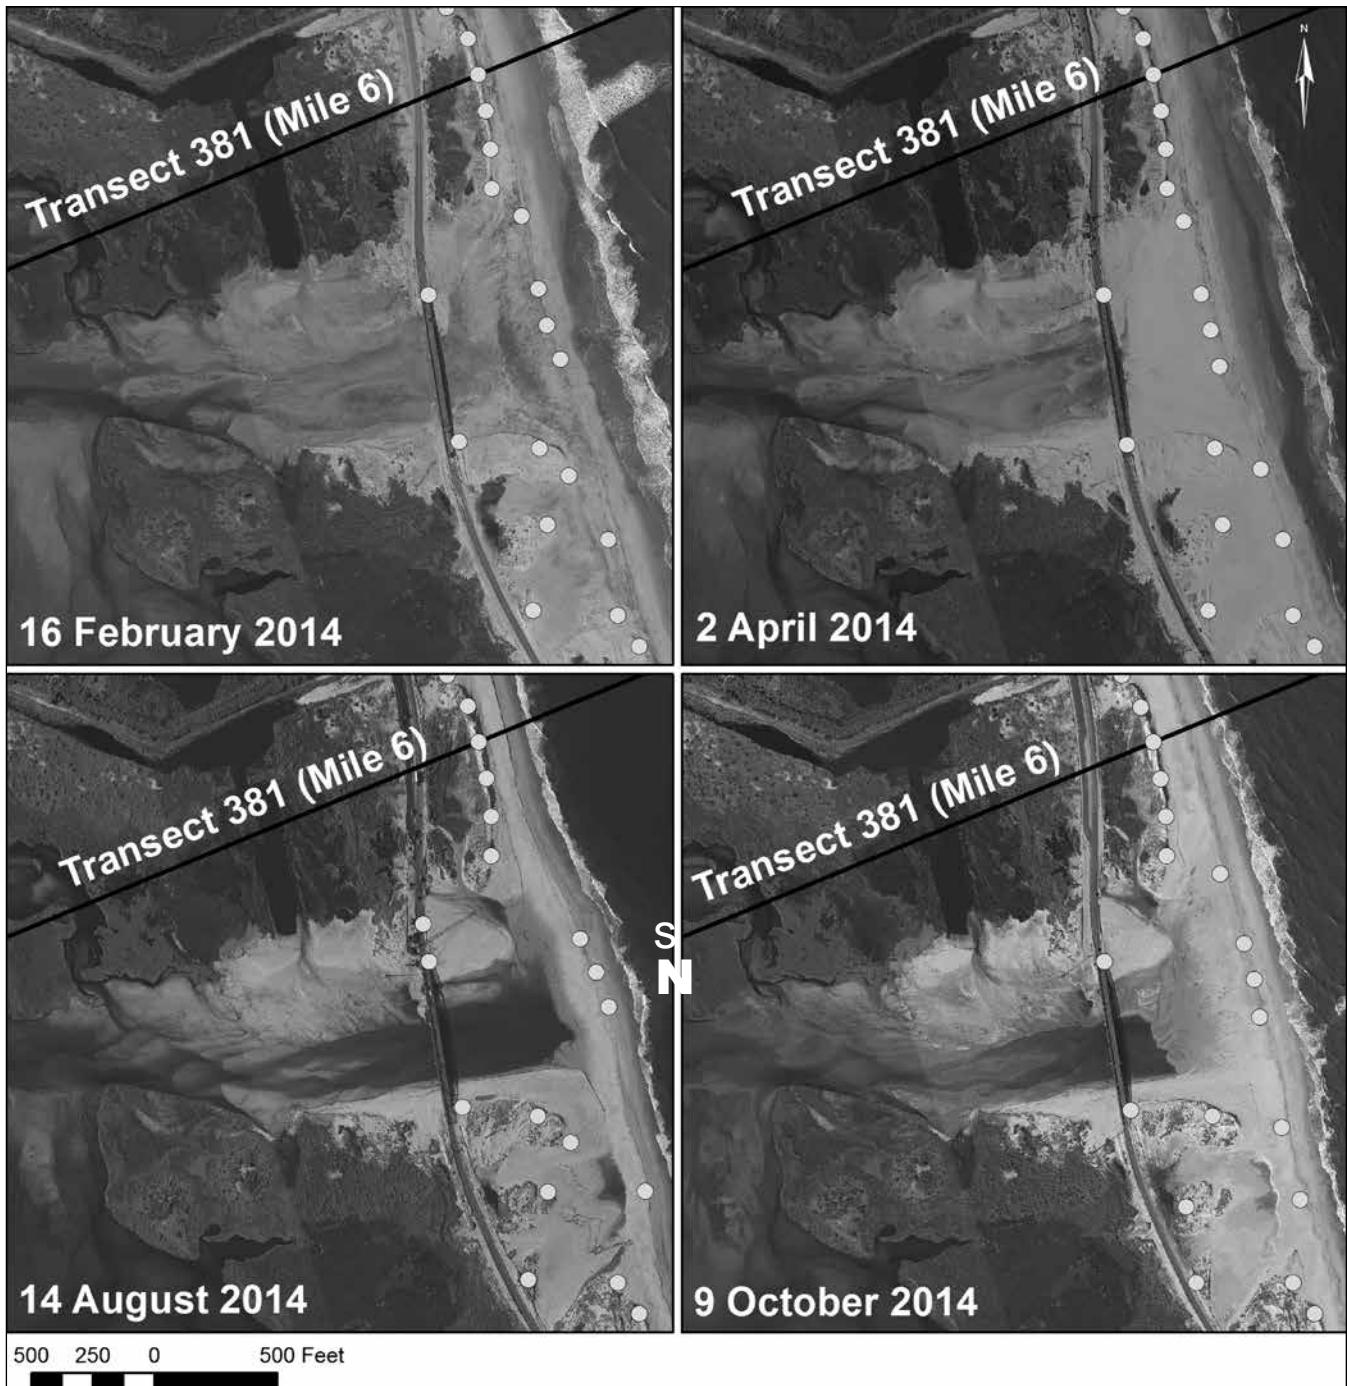
Figure 10. Aerial photography showing the Pea Island Breach throughout the 2014 study year. Dots show the location of maximum profile elevation at individual transects.

Figure 10 shows the evolution of the Pea Island Breach during the 2014 study year. The maximum elevations along the breach itself (where dunes were completely removed) were relatively low throughout the study year (on the order of 5 ft); adjacent areas where some type of dunes remained were on the order of 10-15 ft. In the February and April photographs, the breach was mostly dry with a relatively wide beach seaward of the temporary bridge. In the August and October photographs (after the passage of Hurricane Arthur in July 2014), water from the sound side is shown within the breach extending past the ocean side of the bridge. Figure 11 shows a ground

During 2014, NCDOT was conducting preparatory work for installation of a permanent bridge over the breach (visible in Figure 10 in the April and August photographs). This work was halted as part of negotiations with environmental groups that had made legal challenges to the project to replace the Bonner Bridge over Oregon Inlet (NCDOT 2015).

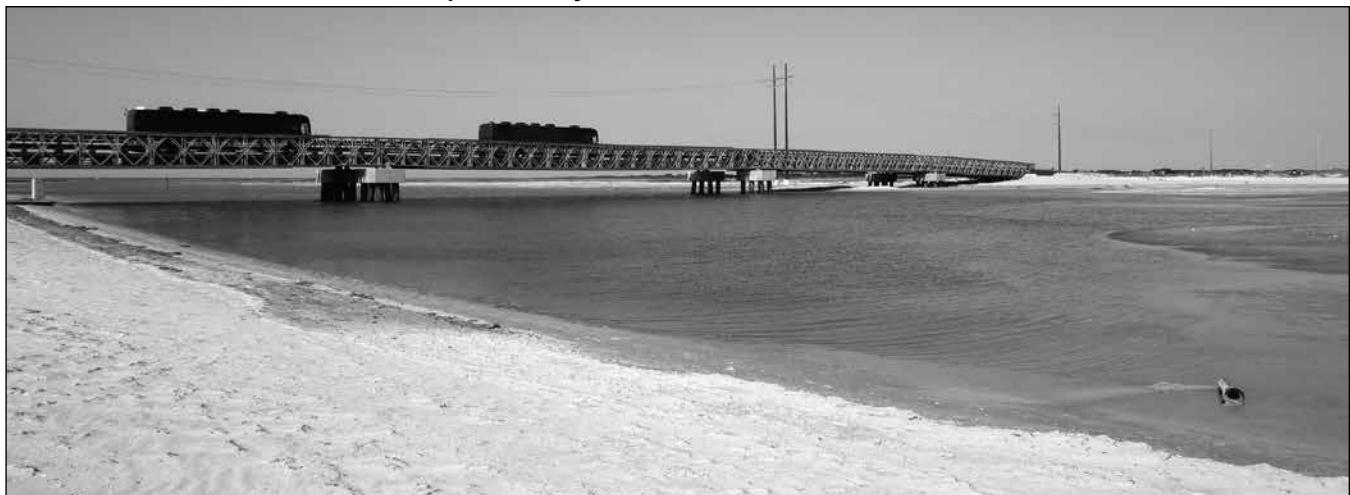
Figure 11. Ground view of the temporary bridge over the Pea Island Breach from the south ocean side, looking north. Photo taken 10 October 2014, L. Velasquez-Montoya.

view of the temporary bridge taken from the south ocean side of the bridge in October 2014. Standing water is visible in this photo as well.

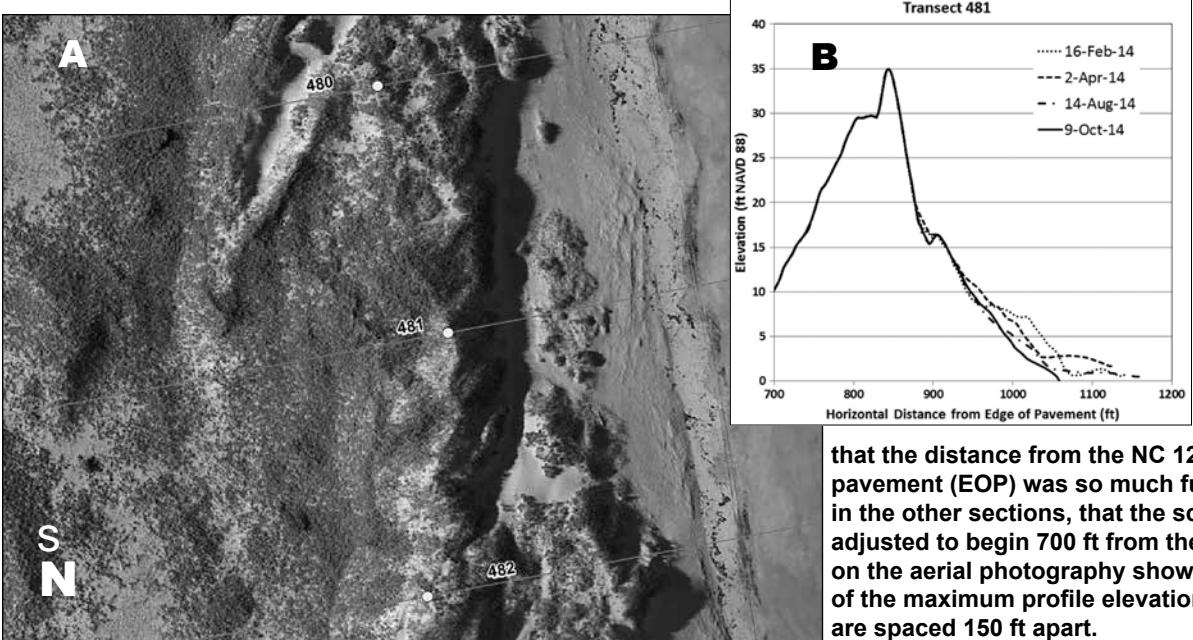
Figure 12.
(A) Aerial photo dated 14 August 2014, showing the stable dune field near Transect 481 (Mile 8.8). The cross-section profile is shown in **(B)**. Note

that the distance from the NC 12 edge of pavement (EOP) was so much further than in the other sections, that the scale was adjusted to begin 700 ft from the EOP. Dots on the aerial photography show the location of the maximum profile elevation, transects are spaced 150 ft apart.

About a mile south of the Pea Island Breach, a stable zone begins, extending approximately 3 miles, where NC 12 is positioned an average of 830 ft from the active beach (as determined by the location of the dune toe). Figure 12 shows an aerial photograph and the typical profile changes observed at the stable area between Miles 7 and 10. Transect 481 (located at approximately Mile 8.8) shows a highly vegetated dune with crest at approximately elevation 35 ft with smaller incipient dunes seaward; profile changes were limited to the beach face. Note that the distance of the dune from the edge of pavement of NC 12 is much greater than the examples shown in the previous sections, and the dune crest at elevation 35 ft is substantially higher than the dune crest in other areas.

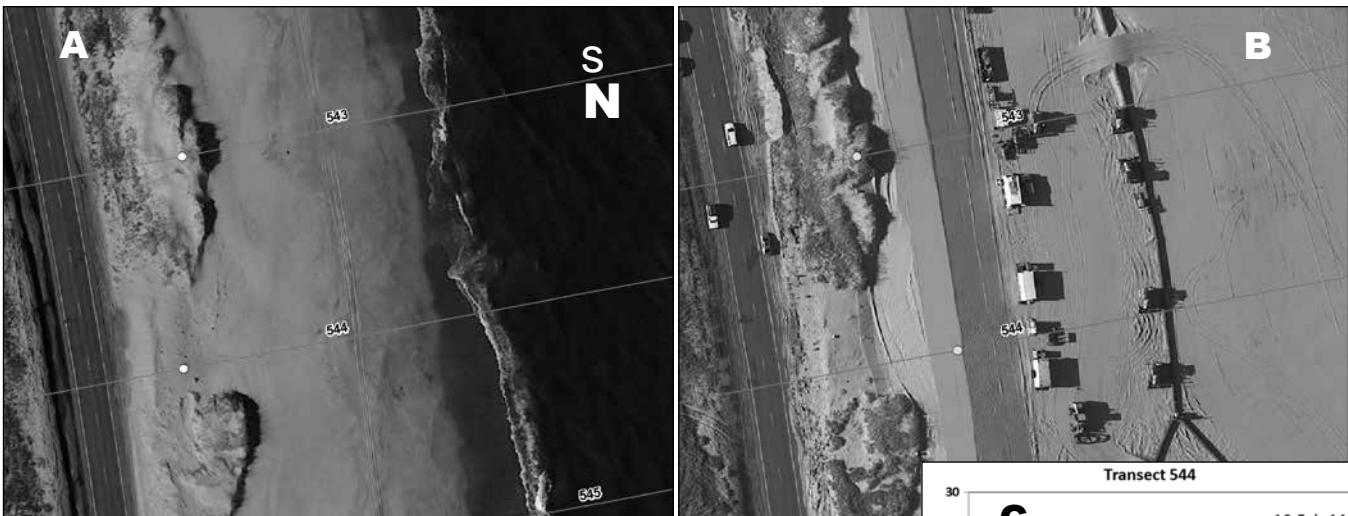
Figure 13. Aerial photos showing the location of the beach nourishment project (A) on 2 April 2014 (dune at Transect 544 (Mile 10.6) was minimal) and (B) on 14 August 2014 after the project was mostly in place, with a constructed dune (indicated by the arrow). The cross section at Transect 544 is shown in (C). Dots on the aerial photography show the location of the maximum profile elevation, transects are spaced 150 ft apart.

The largest increase in maximum elevation for the time period from April to August was attributable to the beach and dune construction efforts underway and occurred at Transect 544 near Mile 10.6 (see Figure 4). Figure 13 presents an aerial view of the beach nourishment project area before the project (2 April 2014), and when the project was in progress (14 August 2014), as well as a cross-sectional profile of Transect 544, which clearly shows the difference between the pre- (16 February, 2 April) and post- (14 August, 10 October) profiles. Note that Transect 543 just north of Transect 544 did not show a change in maximum elevation due to the project; this is because the existing dune field visible in Figure 13 had a maximum elevation greater than that of the constructed dune. Transect 544 was located in a break in that dune field and therefore clearly shows the increase in elevation.
