Beach and dune impacts due to Hurricane Florence in Dare County, North Carolina

Elizabeth J. Sciaudone, Ph.D., P.E., and Liliana Velasquez-Montoya, Ph.D.

North Carolina State University Department of Civil, Construction, and Environmental Engineering,

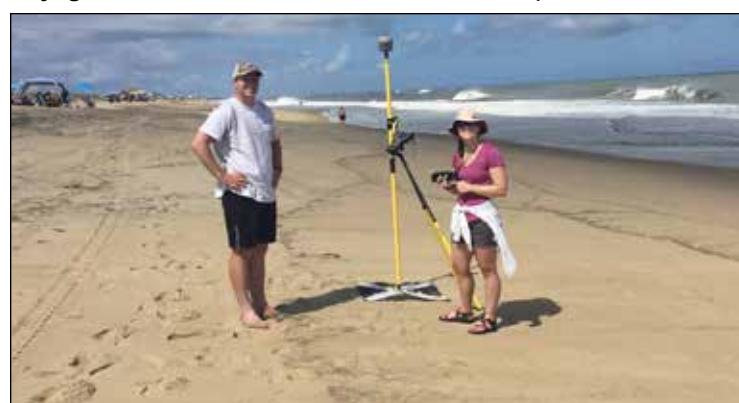
Figure 3. RTK-GPS survey of ground control points for UAS survey.

Topographic ground surveys were conducted using a Trimble R10 RTK-GPS system, with a maximum precision of 8 mm horizontal and 15 mm vertical. The team measured cross-shore beach and dune profiles as well as ground control points for the UAS surveys (Figure 3). Ground Control Points (GCPs) were measured at Kitty Hawk and Nags Head (sites 1 and 2 in Figure 1). Cross-shore subaerial profile surveys were conducted at Pea Island, Rodanthe, Buxton, and Hatteras (sites 3-5 in Figure 1). A total of 25 profiles were surveyed at Pea Island and Rodanthe, 2 in Buxton, and 17 in Hatteras.

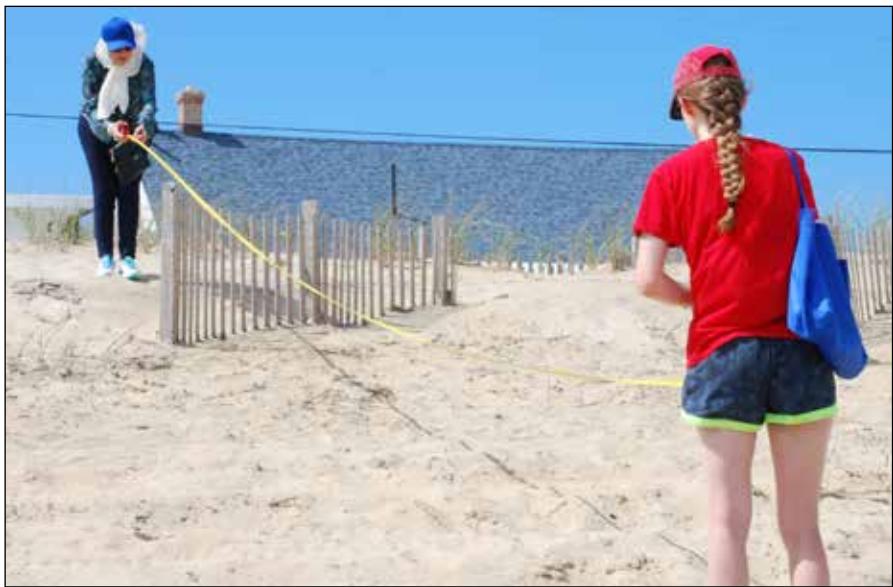
Figure 4. Transect measurement for sediment sampling in Kitty Hawk.

Sediment samples were obtained at each of the field sites, corresponding to the locations of ground survey and/or UAS data collection. In each of the six locations, two to four sampling transects were selected to represent the cross-shore grading conditions. These transects were sequentially numbered from T1 to T13. Along each transect, three cross-shore sampling stations denoted as S1, S2, and S3 were selected. These notations correspond to the dune crest (where present, S1), mid-beach (S2), and the edge of the shoreline (S3). Distances between the samples along each transect varied from 7 m to 24 m depending on the beach width (Figure 4).

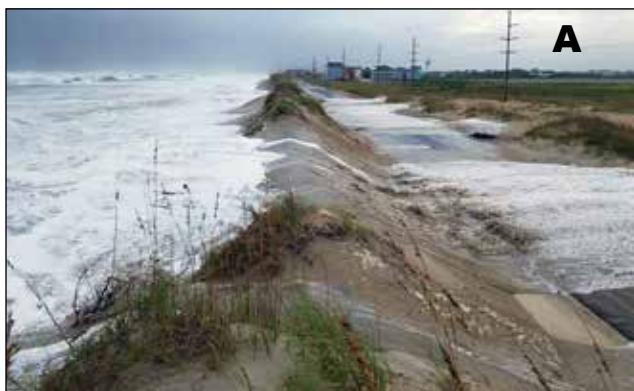
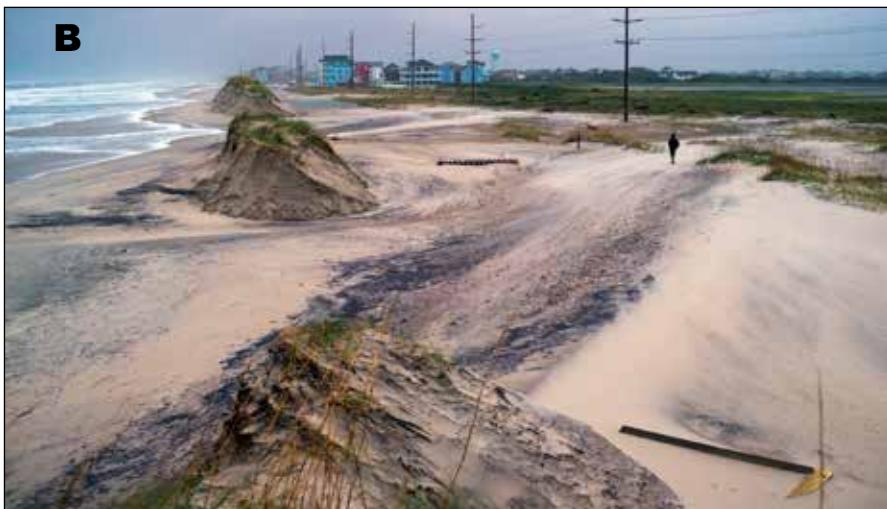
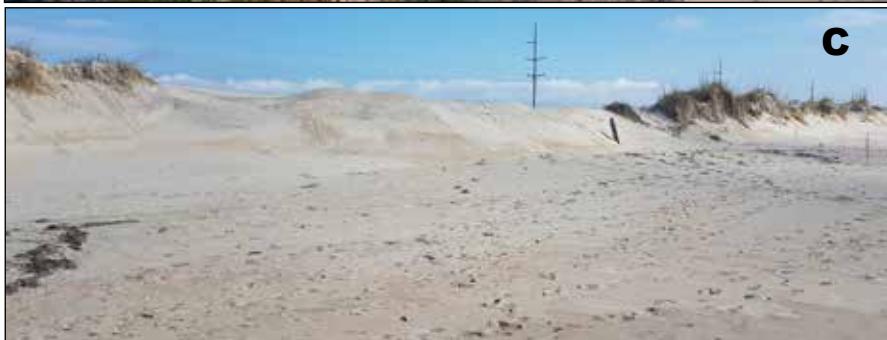
Figure 5. (a)
Overwash on NC 12,
Hatteras Island, 13
September 2018 as
Florence approached
the coast, NCDOT
photo; (b) Same area
as of 14 September
2018, Daniel Pullen
Photography, and (c)
27 September 2018
during field visit, A.
Gharagozlu photo.

Several locations of erosion and overwash events were observed in post-storm aerial photos where dune removal or overtopping occurred during Florence. Figure 5 shows a comparison of images during (a), immediately post-storm (b), and at the time of the site visit (c), for a location just northeast of the town of Hatteras. High waves on top of elevated water levels eroded the dunes and pushed the sediment onto the road. However, by the time of the survey, sand had been pushed off the road and dunes had been rebuilt. As such, the surveyed profile in this location did not represent the actual post-storm dune elevations but rather the recently reconstructed dunes.

The most noticeable overwash on Hatteras Island impacting Highway 12 was found just north of the Town of Hatteras heading toward Frisco (shown in Figure 5). Post-Florence reconstruction of the dune was apparent by the time of the field campaign, indicated by the discontinuity of dune vegetation and asphalt chunks on the crest of the dune. On the landward side of the road an overwash fan was present, outlined in Figure 8. This fan had sand depths ranging from

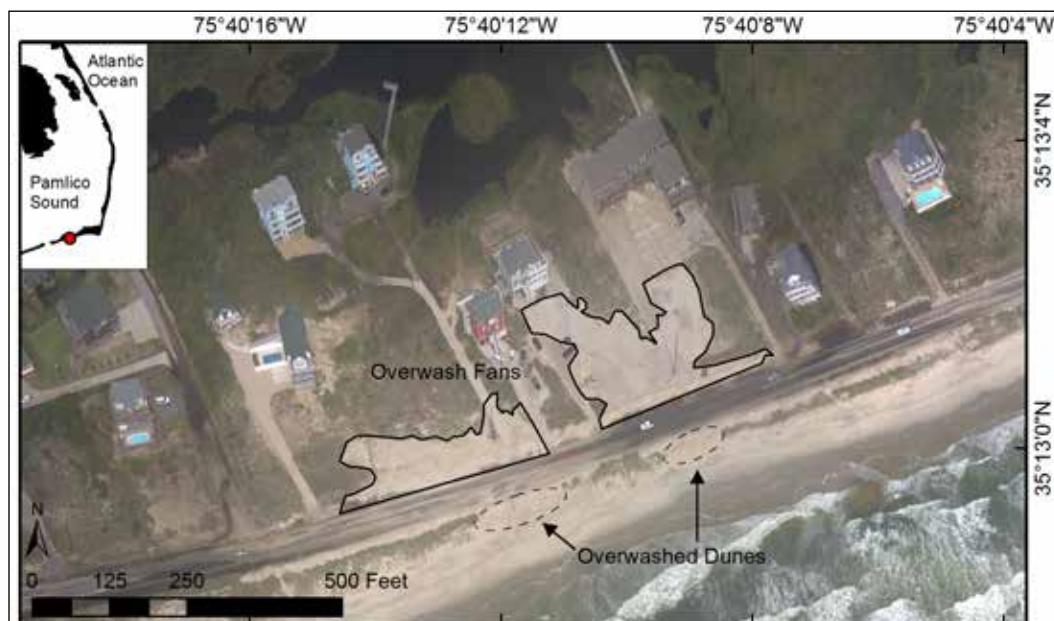
60-630 mm, (2.4-24.9 inches) measured with a standard 1 m stick. Sea oats and other beach grasses were knocked down by the overwash and were heading at approximately 270° from north (Figure 9). Although there were other discontinuities in the dune in this area, it was not apparent whether these dunes had been built up pre-storm or post-storm.

Figure 8. Post-Florence aerial image of overwashed dunes and corresponding overwash fans on Hatteras Island.

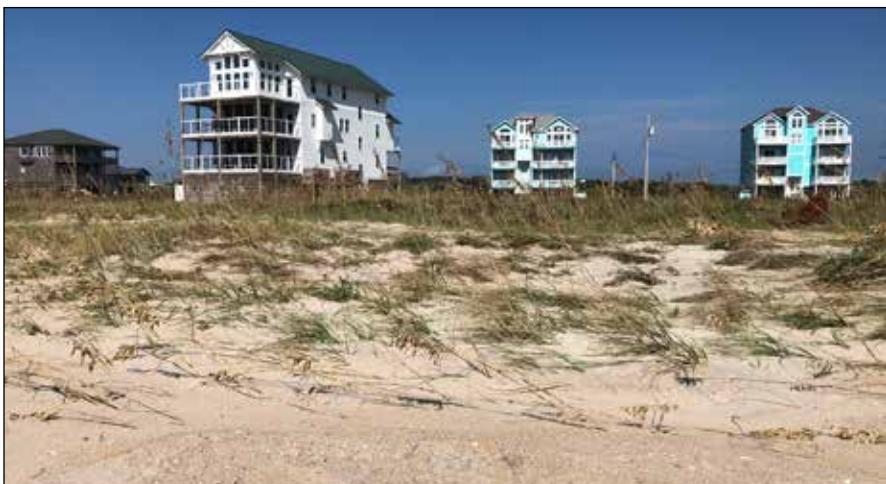
Figure 9. Vegetation knocked over by dune overwash during Florence at location shown in Figure 8. J. Woodruff photo.

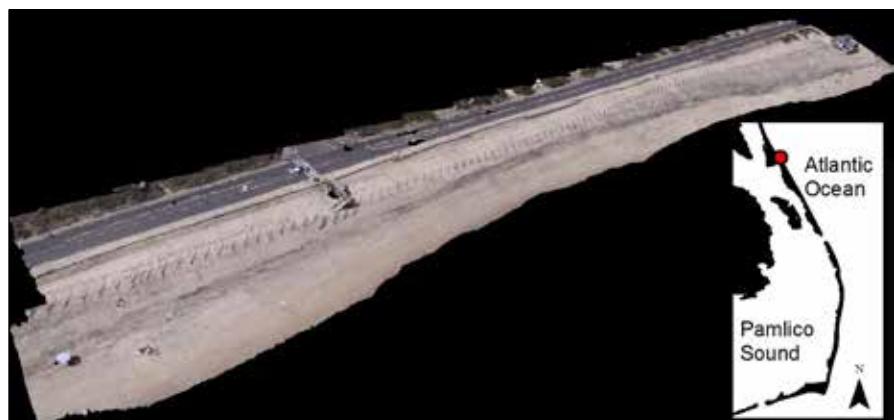
control points at Kitty Hawk, Jennette's Pier, and Nags Head. Figure 10 shows the point cloud data for Kitty Hawk and South Nags Head, as collected by the DJI Inspire. These data have been processed to develop georeferenced digital surface models (DSM). Figure 11 shows a difference map developed using these data as well as data from a previous site visit in May 2017. The video data collected by the DJI Inspire will be used in future work to

Figure 10. Point cloud data developed from imagery collected by DJI Inspire, visualized at plas.io. Top is Kitty Hawk, bottom is South Nags Head.
